PRESERVATION ASSESSMENT AND PLAN FOR SPRINGWOOD CEMETERY, CITY OF GREENVILLE, S.C.

Prepared By:
Michael Trinkley, Ph.D.
and
Debi Hacker

CHICORA RESEARCH CONTRIBUTION 440

March 31, 2006

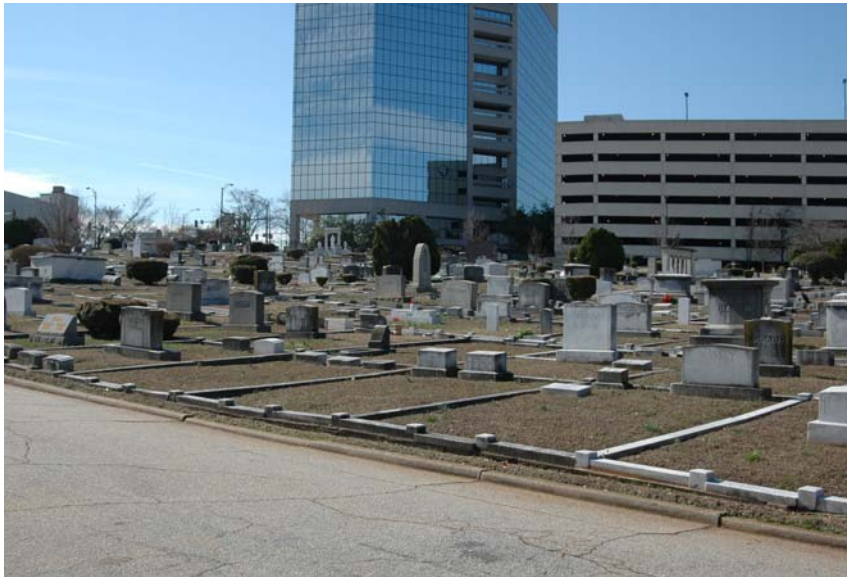
Figure 3. A portion of Springwood with a parking garage and office building in the background – visual intrusions that detract from the historic character of the cemetery.

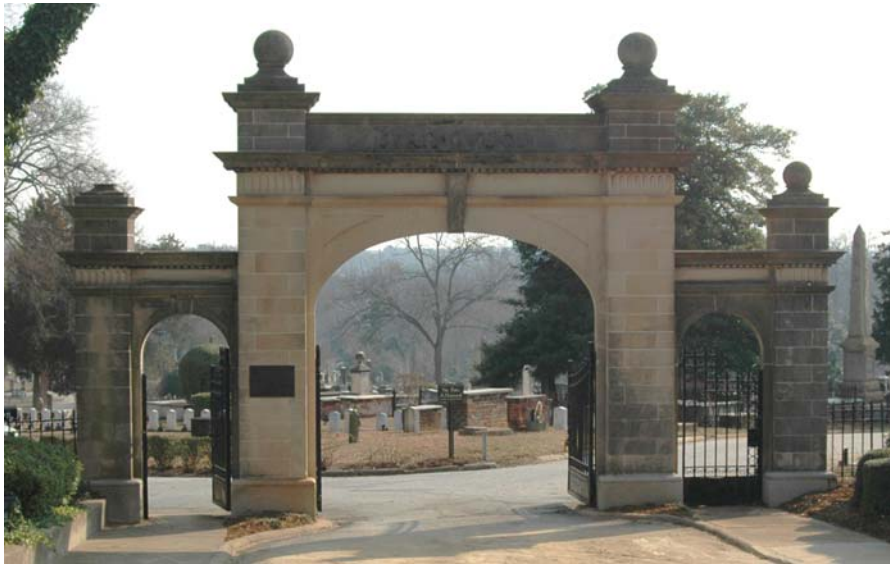
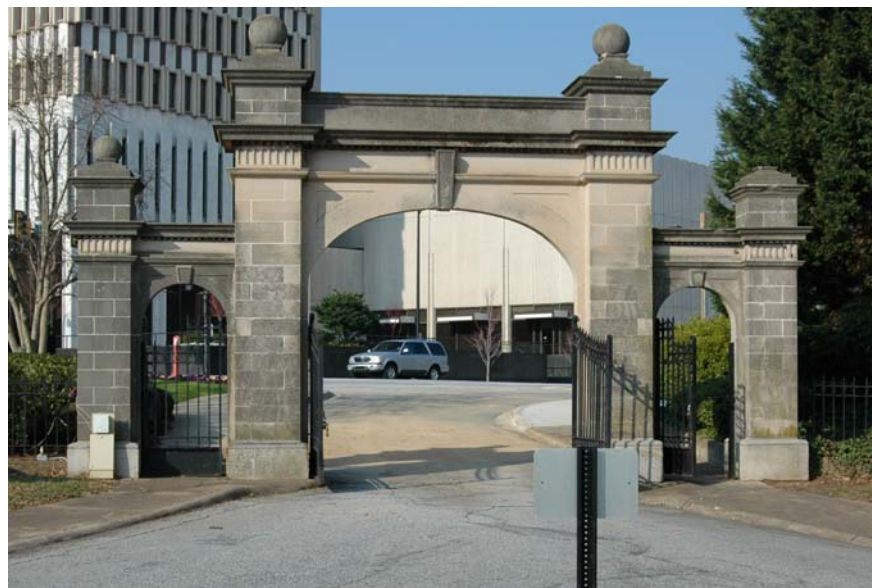
Figure 18. Main entrance gate viewed from Main Street looking into the cemetery (east).

The main entrance was visually evaluated from ground level. No lift was available to allow access to those areas not immediately visible from the ground. Figures 18 and 19 provide overviews of the gate from outside and within the cemetery. It is of sandstone construction set on granite bases.

The visual inspection also reveals that there is a significant joint crack between the main arch and the northern pedestrian entrance. While repointing may be appropriate, it is important to first evaluate whether there is movement in the gate that may suggest foundation settling or failure. One approach

Figure 19. Main entrance gate viewed from within the cemetery looking toward Main Street (west).

There is evidence of at least some blocks spalling. This is a common problem with

would be to install crack monitors and evaluate any movement over the next 6 months. The City should also seek to minimize any construction in the vicinity that might cause ground movement or vibration since this could adversely affect the gate's stability.

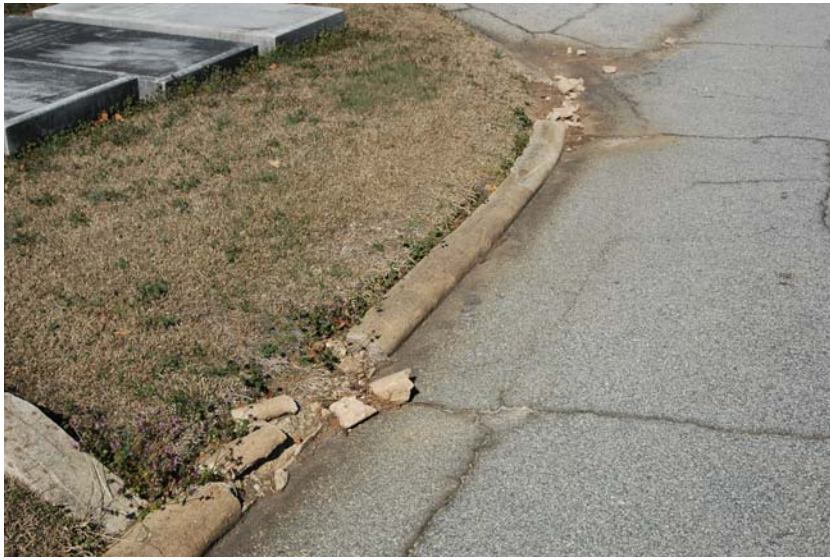
Figure 22. Example of deteriorated and failed concrete curbing. Note also the pavement cracks.

The concrete curbs are generally in poor condition (Figure 22) with approximately 690 linear feet identified as needing to be cut out and replaced. Much of this damage appears to be the result of a bad mix, perhaps with the problem exacerbated by Greenville's freeze-thaw cycle. Regardless, the curbing has

significantly deteriorated, resulting in spalled sections, mixture reduced to loose aggregate, erosion of lawn areas, and dramatically reduced aesthetics.

Should this work be contracted out, rather than being done in-house by the City, the cost is around \$1.17 per linear foot and we estimate there are approximately 11,000 linear feet of cracks (this is based on sampling limited to the older section of the cemetery, so the actual number of linear feet may be less than this). Consequently, we recommend a budget of approximately \$12,900 for this work.

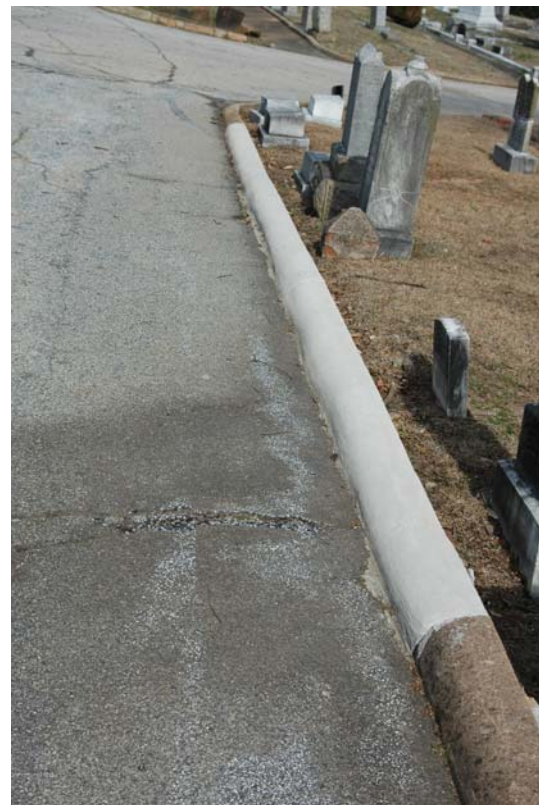
Figure 23 reveals a section of curbing apparently replaced by the City. It is critical that replacements match the original, historic curbing in composition, design, color, and texture. The City has done an excellent job of replicating the curbing profile. The texture and especially the color, however, are mismatched and this should

Figure 23. Recently replaced curb. The profile match is excellent, but the color and texture are both incorrect.

be corrected on all future repairs.

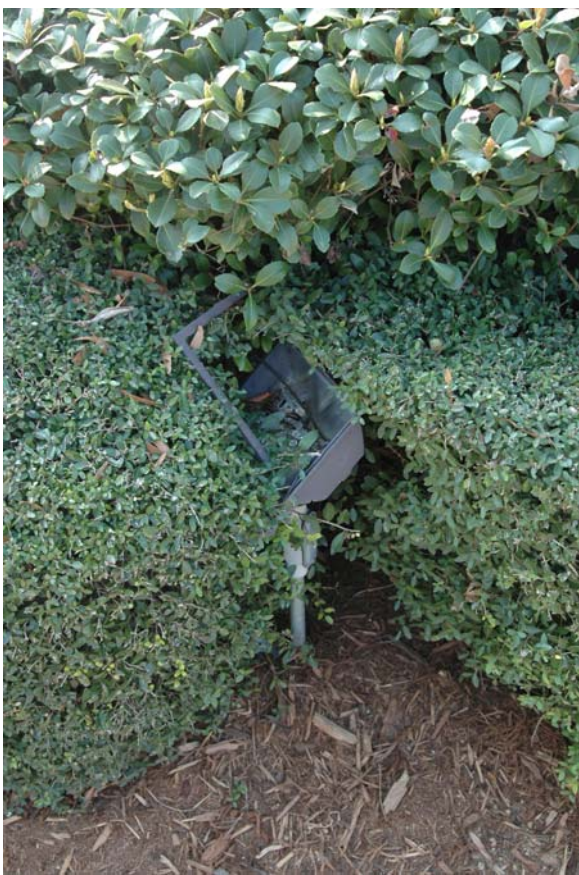
Figure 26. Vandalized lamp intended to illuminate the main Springwood Cemetery entrance at night.

discovered that at least one lamp had been vandalized and probably had not been working for months (Figure 26). Moreover, given the extensive pruning in this area, City work crews must have seen the damage – as we did – and chose to ignore the problem. This reflects poorly on the professionalism and dedication of those performing this work.

The City's electrical department should check this and the other lamps that may be present, and ensure that they are working. Those which are found to be damaged should be replaced. If the problem persists, vandal resistant housings may be necessary.

We also recommend that the shrubbery be pruned away from the lamps to avoid damage from the heat generated by the lamps, minimize the potential from pruning damage, and ensure that the light is not obscured by vegetation.

Lights on the main entrance should be repaired or replaced by the City immediately. They should be periodically (at least monthly) inspected to ensure that they are operating correctly.

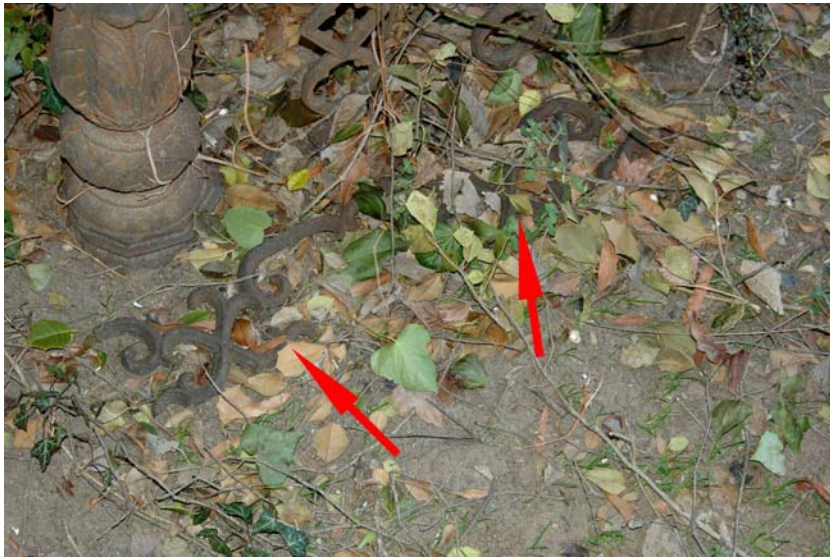
Figure 31. Examples of broken fence ironwork lost in the grass and leaves.

collecting, resulting in the loss of historic fabric. The City should collect, label, and store all such individual parts until such time as repairs can be made – the individual parts should never be allowed to remain loose in or around the plots. If the City has no facility where the parts can be securely stored, then it would also be acceptable to use woven stainless steel wire to attach the parts discreetly to their respective fences – securing the parts on-site.

Loose ironwork at Springwood should either be collected, labeled by plot, and stored securely or should - at a minimum - be secured to other ironwork on the plot using woven stainless steel wire.

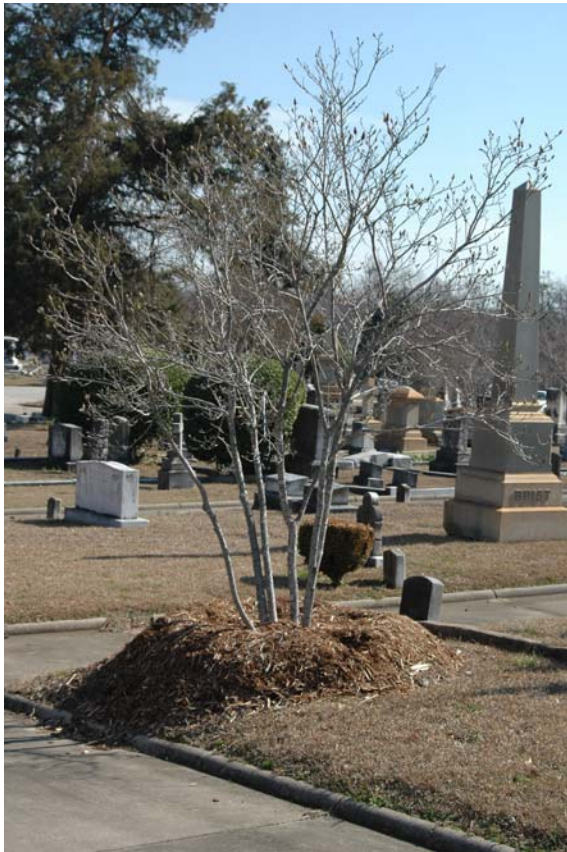
We observed several newly planted trees that appear to be over-mulched. At least one, as the mulch was removed from the trunk, evidenced bark decay. This will lead to disease, weakness, and premature loss of the tree. Staff should be more closely supervised to prevent over mulching of vegetation.

Figure 34. Example of over mulching. Mulch should not exceed 3-4 inches.

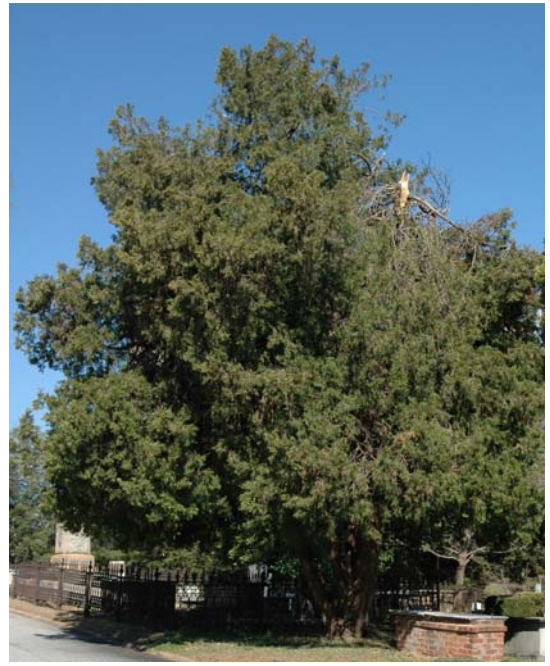
Our visit admittedly came on the heels of a bad winter storm that resulted in the downing or damage to a number of trees. Nevertheless, we observed considerable damage and questionable pruning practices, including the topping of trees (Figures 35 and 36), failure to remove deadwood (Figure 37), failures to correct ice weight damage (Figure 38), and failure to correct long-term failures (Figure 39).

Figure 36. Topped cedar tree. Here there is no evidence of remedial action.

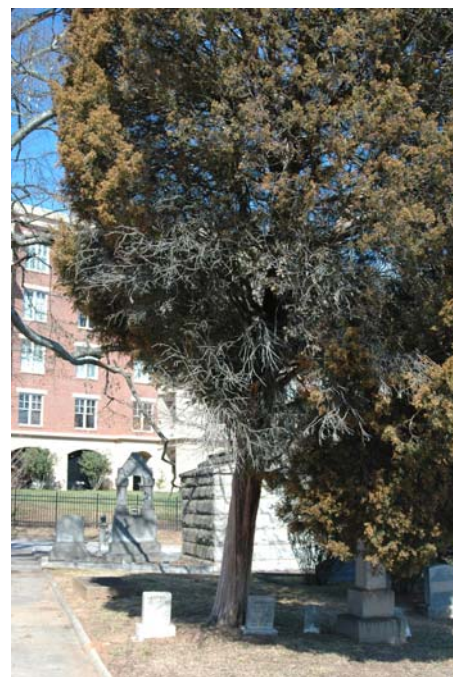
Figure 37. Dead branches in cedar.

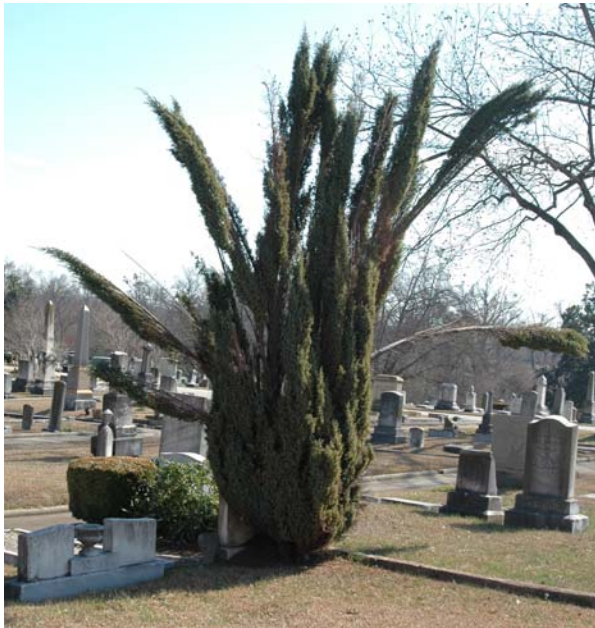
Figure 38. Ice likely weighted these limbs down and damaged the natural shape of this tree.

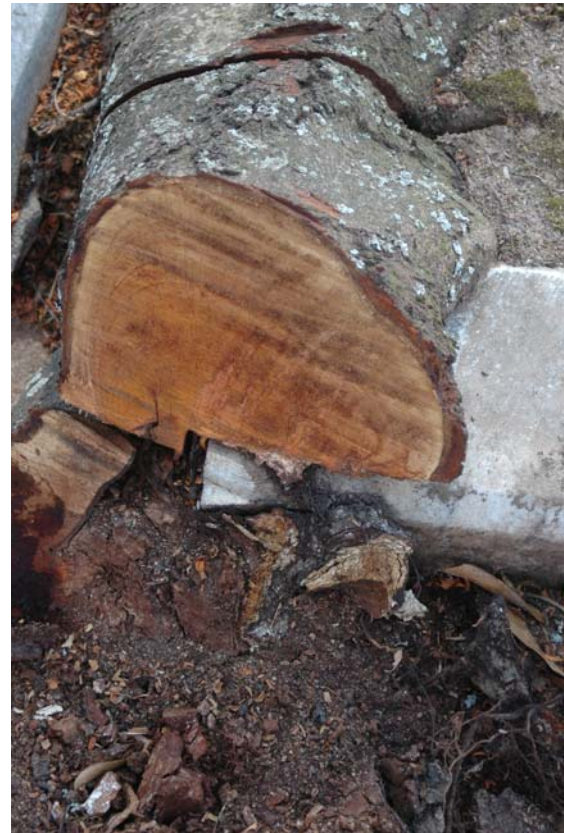
Figure 41 illustrates the removal of a tree damaged by the recent ice storm where a surface root, having been allowed to overgrown plot coping, was then removed. In the process, the chainsaw was allowed

Figure 41. Example of marble coping damaged by a chainsaw as a surface root was being cut. Additional care is required to prevent this sort of "accident."

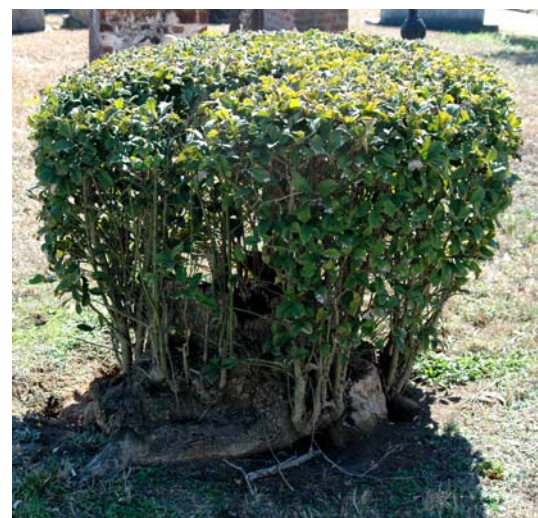
Figure 42 illustrates a situation where a holly tree was removed, but suckers were allowed to grow and have subsequently been

Figure 42. Holly tree suckers pruned into a shrub.

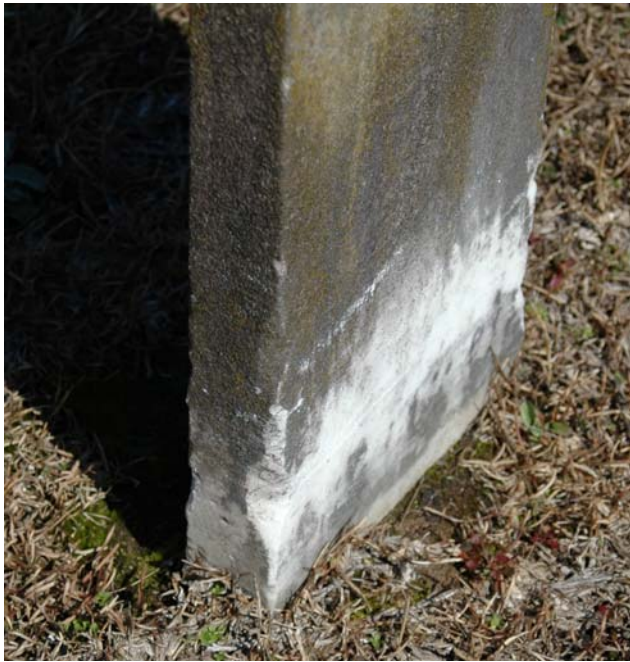
Figure 46 reveals damage done to a marker by the impact of a mower. All mowers used in the cemetery should have a closed cell foam pad attached to the sides and front edges. This bumper will help to minimize accidental damage. Figure 47 illustrates the damage that can be caused by the use of nylon trimmers with line that is too heavy.

Figure 46. Example of mower damage at the corner of a marble headstone.

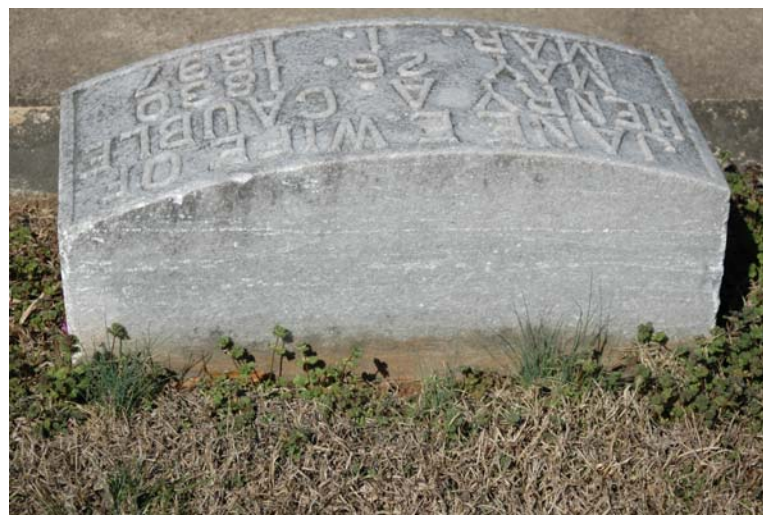
Figure 47. Example of nylon line trimmer damage to a stone.

In addition to mowing, nylon trimmers are used around monuments, coping, fencing, and plantings. This is an acceptable practice, but it is critical that a very light weight line be used – along with worker attention – to minimize damage to soft stone such as marble. Although the staff thought that .0054-inch line was being used, we discovered during our assessment that all of the trimmers were actually fitted with .155 inch Husqvarna TrimForce line. This is the heaviest line manufactured by this company and it has a hexagon-shaped design with six cutting edges. This line is very harsh and should be immediately replaced with a .065-inch line.

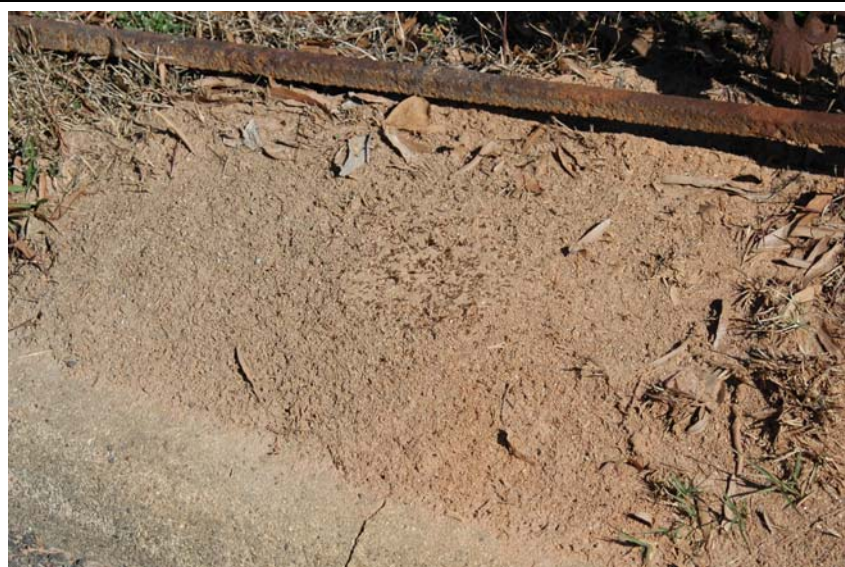
The staff indicated that they were engaging in both individual mound treatments and broadcasting baits. If this is correct, the treatment methods need to be re-evaluated since the level of activity was beyond what should be evident with such a program. We recommend that, minimally, individual mounds be treated with a product such as Amdro (hydramethylnon). An even better approach is

Figure 48. Example of the fire ant problem at Springwood Cemetery.

the use of Amdro as a broadcast fire ant baits while fire ants are foraging. After 10 -14 days it should then be used as an individual mound treatment on any mounds that continue to be a problem. This approach should be used twice a year, typically in April or May and again in September or October.

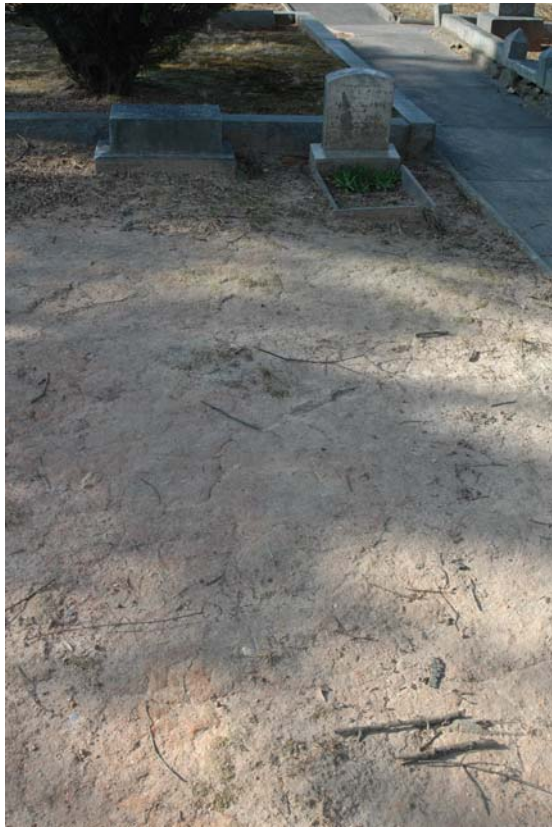
In most areas lacking grass, it appears that one significant problem is compaction and

Figure 49. Example of a highly compacted soil that is devoid of vegetation. We recommend renovation of the centipedegrass in this area.

the upper 6-9 inches of unsatisfactory soil and replace it with a prepared soil. Such removals should be evaluated for archaeological remains, but we observed few indications of archaeological resources in these areas.

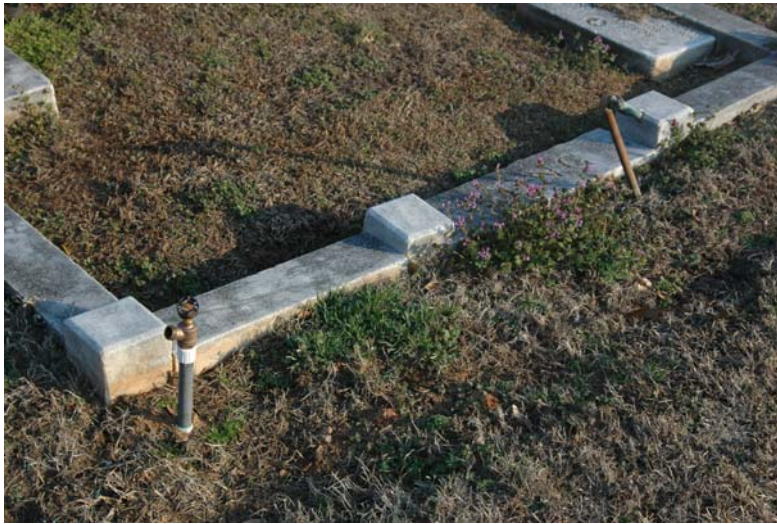
It appears, however, that some lines are now dead and have been replaced. Unfortunately the old pipes have not been capped below grade and the bibs have not been removed. This results in an untidy and cluttered appearance. The City should determine which bibs no longer function and remove them entirely.

Figure 50. Old hose bibs should be removed so the landscape isn't cluttered with multiple bibs only a few feet apart.

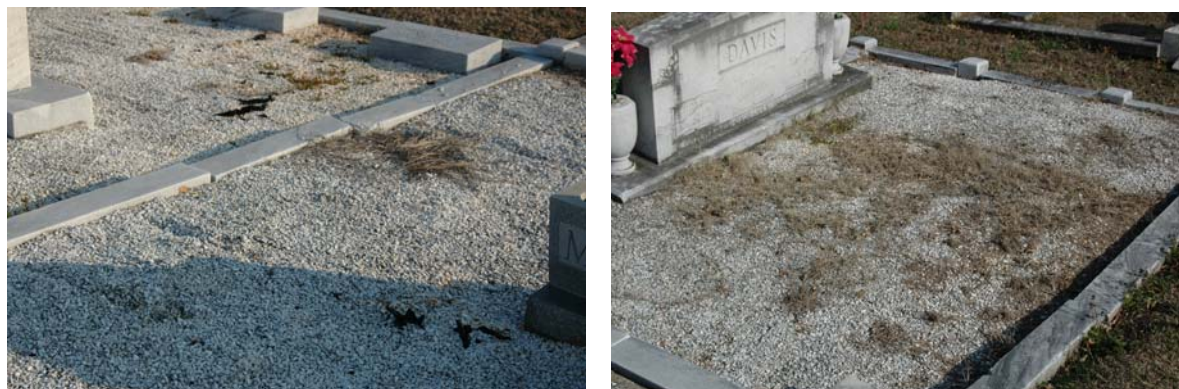
the weed block and gravel. The typical solution to this, rather than laborious hand weeding, is to apply herbicides. Since there is rarely an effort made to prevent future weeds, chemical control becomes a routine practice – causing long-term damage to the memorials. In addition, the weeds killed by the herbicide create a disheveled appearance that detracts from the overall cemetery aesthetics.

Figure 51. Examples of graveled plots. On the left the weed block has deteriorated and is exposed. Both plots reveal heavy weeds that have been treated with herbicides. While the grass is killed, it is left in the lots, detracting from their appearance. The herbicide will also pose long-term problems for the monuments and coping. The City should seek to eliminate the use of gravel in Springwood – it is both a significant maintenance issue and also out of character for the historic cemetery.

and are unwilling to allow grass, they should be informed that it is their responsibility to replace weed block and periodically infill plots with additional gravel in order to keep them maintained. With the realization of that gravel is not a “silver bullet,” but will require long-term maintenance, families may be willing to allow plots to be converted to grass which is more historically appropriate and dramatically softens the cemetery landscape.

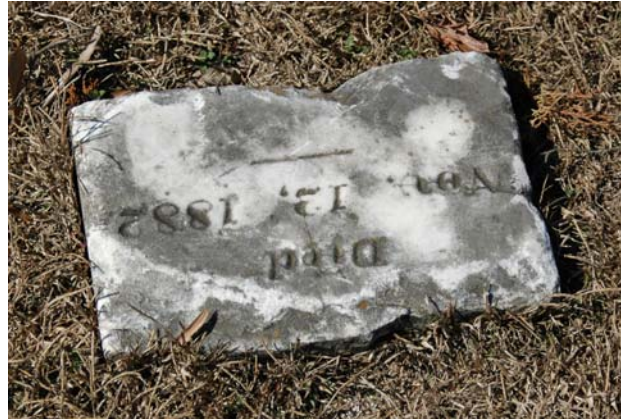
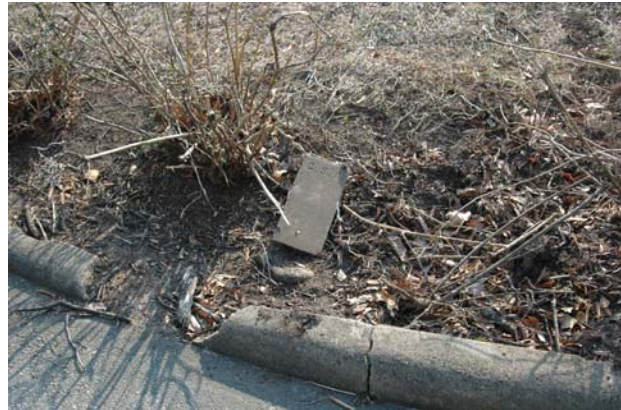
There are displaced stones throughout the cemetery, almost always in plain view. None, however, are being replaced or even being picked up and secured. As a result, stones are being routinely damaged by mowing activities and present an attractive target for thieves and souvenir hunters (Figure 53).

Figure 53. Examples of displaced stones in the cemetery. The upper photograph shows a stone evidencing heavy mower damage – the result of being run over by mowers. Below is a displaced C.S.A. marker in dead shrubbery at the edge of the road – providing an attractive souvenir for theft.

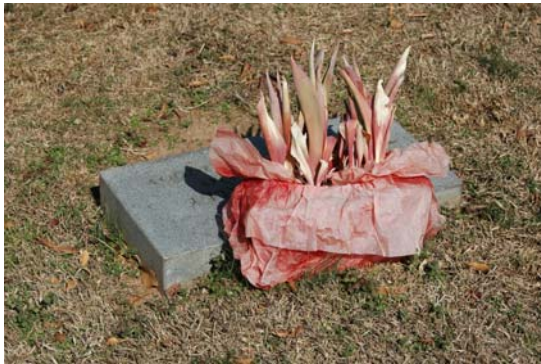
At the time of our visit in late February the cemetery was littered with fading and decaying plastic Christmas decorations. These detract from the dignity and beauty of the cemetery and individual lots. They also never decompose, but continue to litter the landscape until eventually collected and disposed of.

Figure 54. Old, faded, wilted, or deteriorated floral arrangements must be collected and disposed of by the City.

The ideal would be to allow only fresh flowers on Springwood graves. As the flowers faded, even if not removed, they would mulch into the landscape and pose little or no maintenance problem. If the City is unwilling to take this step, then minimally the existing requirement that all flower decorations either be removed by lot owners or cemetery staff should be enforced. Section III, Vegetation Management of the City of Greenville Rules and Regulations of Municipal Cemeteries specifies:

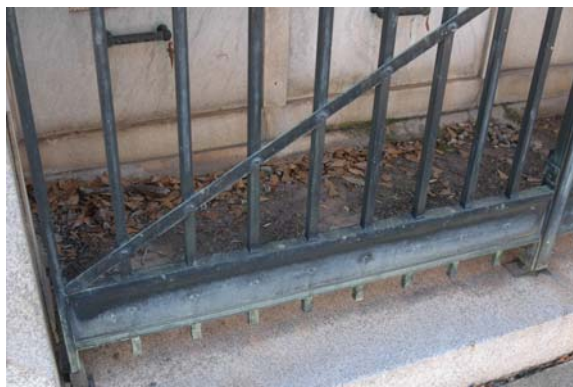
During this assessment we noted that mausoleums at Springwood exhibited a range of problems including broken stained glass

Figure 55. Debris accumulating within an open mausoleum.

Several of these problems, including the broken stained glass, broken locks, and deteriorating masonry, are of sufficient severity that the City should notify the lot owners of their requirement to effect repairs. Failing timely steps to resolve the problems (i.e., replace the stained glass window – an aesthetic blight; repair the broken lock – a security and public safety issue; repoint the masonry – representing hazardous deterioration of the masonry), the City will need to take action to repair these problems.

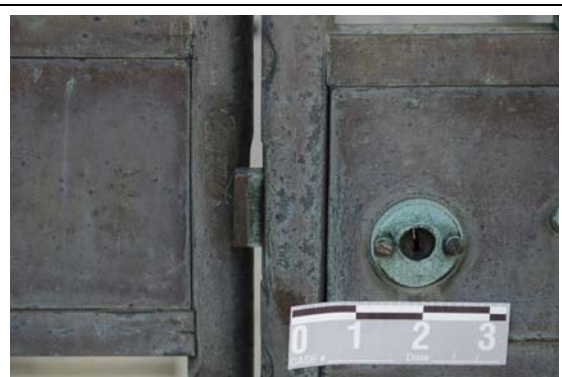
Figure 56. Brass doors of a mausoleum that have been locked open.

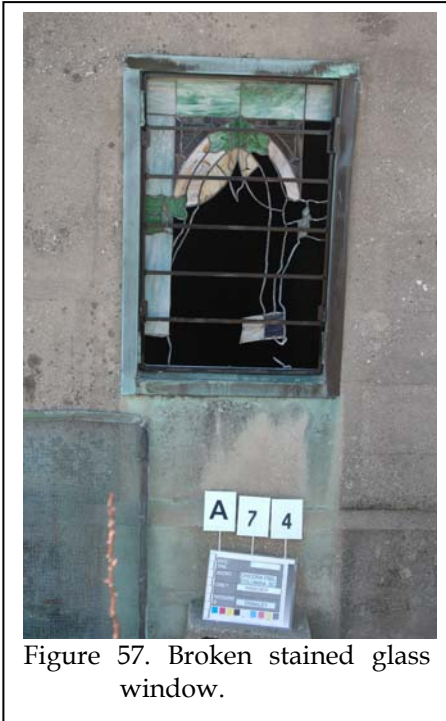
Figure 57. Broken stained glass window.

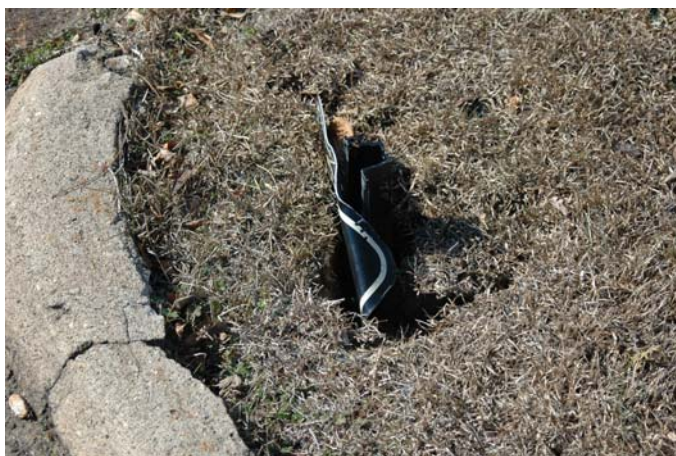
Figure 58. A recently erected section marker has been severely damaged by traffic. Placement of signs is not sufficient, the Cemetery must also periodically inspect, repair, or replace signage as well.

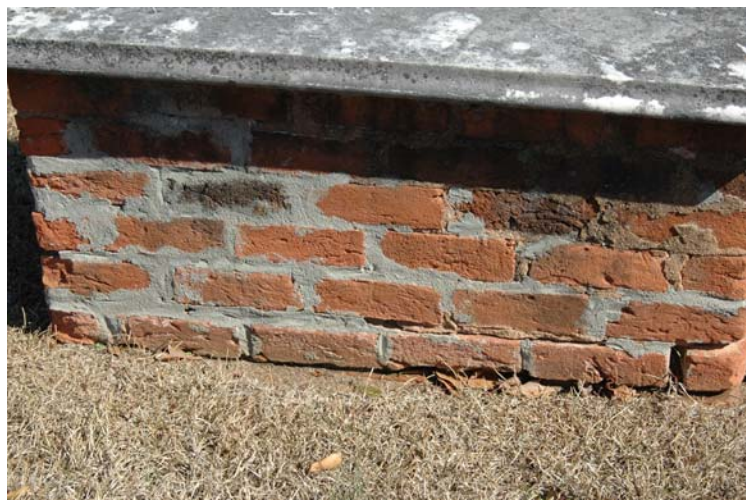
Figure 59 illustrates a typical job of repointing from Springwood. Three primary issues are clearly visible. First, the mortar used for this job (seen in the figure as the light gray material) is a hard Portland cement mortar – far harder than the surrounding brick. In addition, no effort has been made to match the color of the original mortar. Second, the mortar has been “buttered” over the joints, greatly increasing the normal joint width and dramatically changing the appearance of the box tomb. And third, the joints have not been finished in any fashion. Overall, this is an entirely unacceptable job that is both aesthetically disturbing and inherently damaging to the soft, low fired bricks.

Figure 59. Example of very poor repointing of a brick box tomb at Springwood Cemetery.

The specifications are more detailed than this brief overview, but this should serve to indicate the care required – and demonstrate how the workmanship seen in Figure 59 is unacceptable for a cemetery having the historical significance of Springwood.

All repointing should minimally meet or exceed the specifications established by *Preservation Briefs 2: Repointing Mortar Joints in Historic Masonry Buildings*.

New mortar must conform to the following criteria: (1) it must match the historic mortar in color, texture, and tooling, (2) it must have greater vapor permeability and be softer than the masonry units, and (3) it must be as vapor permeable and as soft as the original mortar.

To achieve these criteria it may be necessary to have a conservator conduct a mortar analysis. It is also inappropriate to specify a single mortar that is appropriate for all preservation work, especially at a cemetery such as Springwood where a variety of time periods and original mortars are present. However, in general, the mortar should be high in lime and low in compressive strength. A natural hydraulic lime (NHL) or air lime would generally be specified for such work. For example, an air lime or NHL 2.5 might be mixed at the ratio of 0:1:3 for much repointing work at a cemetery such as Springwood. The sand selection would be especially critical since that additive would primarily determine the final color of the mortar.

minimum depth of 15/16-inch. The repointing mortar, generally mixed somewhat dry to minimize shrinkage and reduce cleaning efforts, would be firmly packed in the thoroughly cleaned and moistened joint using lifts no deeper than 1¼-inches.

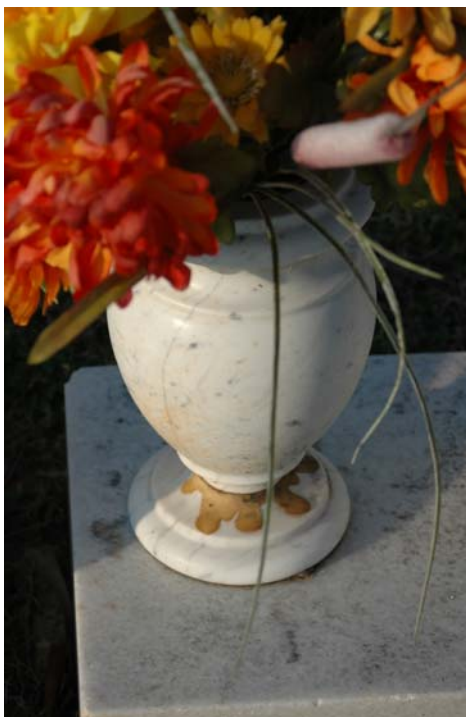
We observed several marble repairs in the Cemetery and Figure 60 is generally typical. An epoxy has been used, which is not necessarily inappropriate. The workmanship,

Figure 60. Typical repair of broken marble showing a lack of care and lack of familiarity with epoxy adhesives.

however, is substandard. The individual doing the work apparently did not understand the

There is no single specification for the repair of marble or sandstone, but in general we can caution the City and the Friends of Springwood that modern monument dealers are unfamiliar with historic stone and have little or no appropriate experience in its care and repair. When repairs of old stones are needed, only a stone conservator who subscribes to the Standards of Practice and Code of Ethics of the American Institute for Conservation of Historic and Artistic Works (AIC) should be retained.

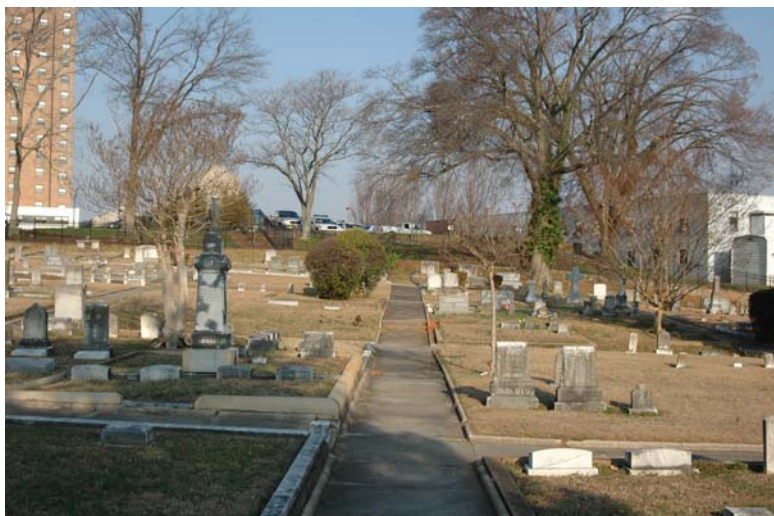
If there is a need for a “buffer between the Court House facility and cemetery,” then this may be achieved using vegetation. But we did not find a significant need for such a buffer, especially when this vista is compared to those toward the southwest and southeast. The

Figure 62. The historic character and landscape of the cemetery would be dramatically affected by the construction of mausoleum at the rear of Section C.

elevation of the Court House reduces much of the visual intrusion.

Modifications, such as the introduction of new elements, if necessary at all, should be focused in the newer areas – or should be undertaken at an entirely new cemetery. Introductions in the historic landscape, where necessary, should be compatible and consistent with the section they are being proposed for.

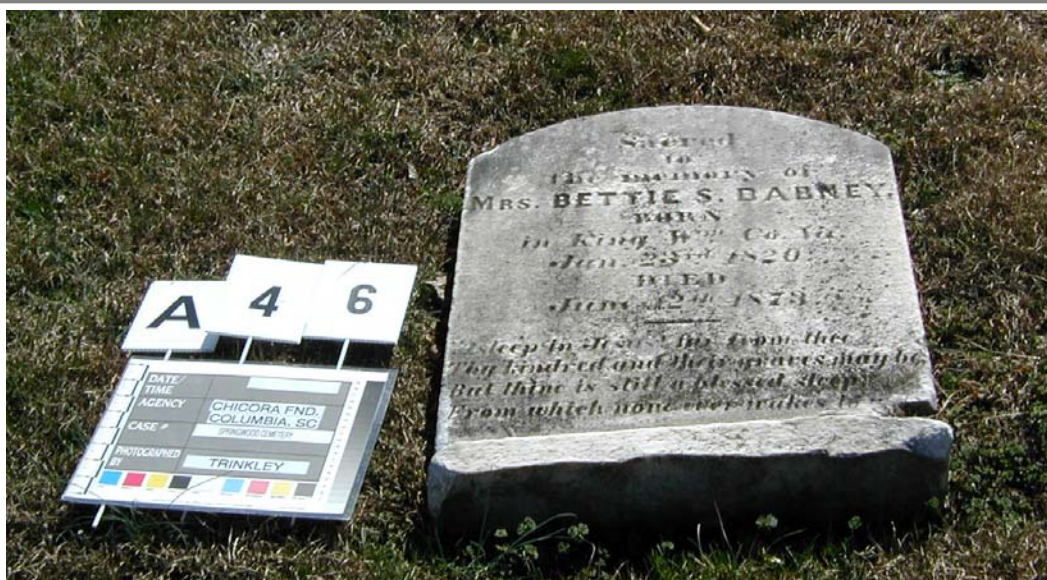
Position: ☒ fallen ☐ unstable ☒ tilted ☐ unattached/loose ☐ missing ☒ shifted

Deterioration: ☒ broken ☐ cracked ☐ losses ☐ flaking/sugaring ☐ ferrous pins
☐ delamination/detachment ☐ missing fragments ☐ other:

Soiling: ☒ biological ☐ staining ☐ efflorescence ☐ other:

Position: ☐ reset in ground ☒ reset/level to existing base ☐ construct new base
☐ possible new base required ☒ stabilize foundation ☒ resquare

Treatment: ☐ core drill ☒ drill and pin ☐ adhesive repair ☒ infill w/Jahn or U.S. Heritage
☐ injection grout ☐ replace bricks ☐ mortar ☐ repoint ☐ other:

Cost: \$950

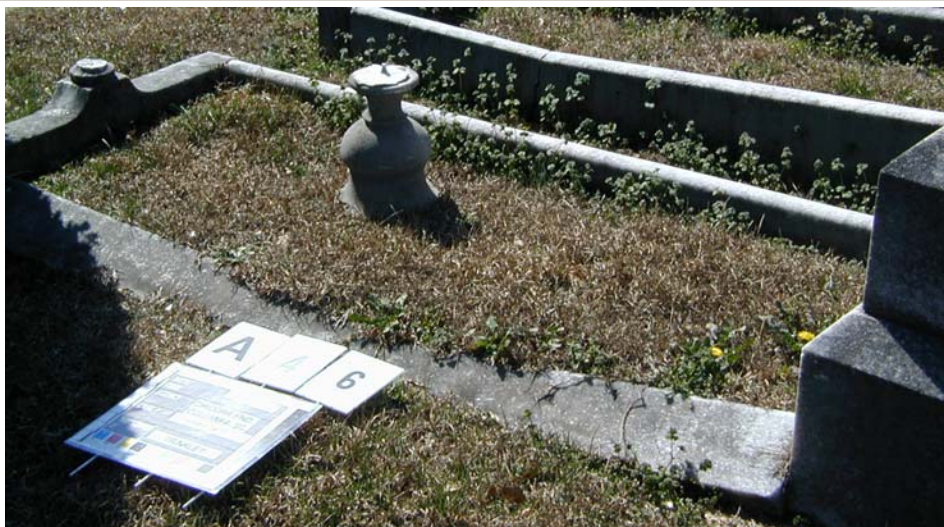
Position: ☐ fallen ☒ unstable ☐ tilted ☒ unattached/loose ☐ missing ☐ shifted

Deterioration: ☐ broken ☐ cracked ☐ losses ☐ flaking/sugaring ☐ ferrous pins
☐ delamination/detachment ☐ missing fragments ☐ other:

Soiling: ☒ biological ☐ staining ☐ efflorescence ☐ other:

Position: ☐ reset in ground ☒ reset/level to existing base ☐ construct new base
☐ possible new base required ☒ stabilize foundation ☐ resquare

Treatment: ☐ core drill ☒ drill and pin ☐ adhesive repair ☐ infill w/Jahn or U.S. Heritage
☐ injection grout ☐ replace bricks ☐ mortar ☐ repoint ☐ other:

Cost: \$1800

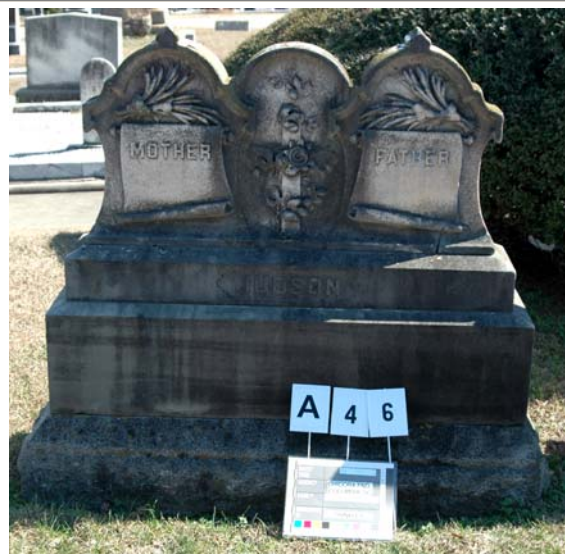
Position: ☒ fallen ☐ unstable ☐ tilted ☒ unattached/loose ☐ missing ☐ shifted

Deterioration: ☒ broken ☐ cracked ☐ losses ☐ flaking/sugaring ☐ ferrous pins
☐ delamination/detachment ☐ missing fragments ☐ other:

Soiling: ☒ biological ☐ staining ☐ efflorescence ☐ other:

Position: ☐ reset in ground ☒ reset/level to existing base ☐ construct new base
☐ possible new base required ☐ stabilize foundation ☐ resquare

Treatment: ☒ core drill ☒ drill and pin ☐ adhesive repair ☒ infill w/Jahn or U.S. Heritage
☐ injection grout ☐ replace bricks ☐ mortar ☐ repoint ☐ other:

Cost: \$725

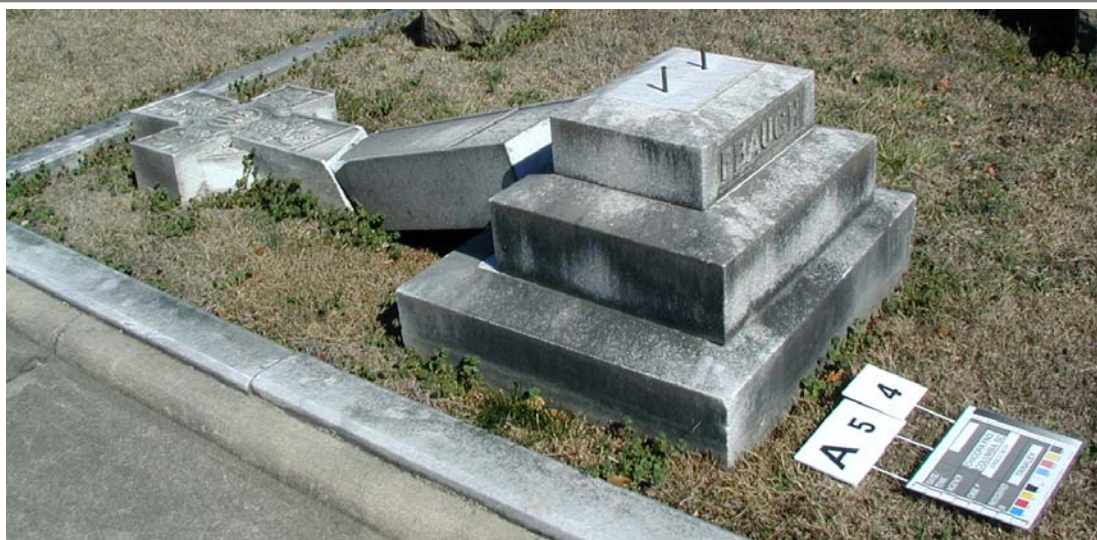
Position: ☒ fallen ☐ unstable ☐ tilted ☐ unattached/loose ☐ missing ☐ shifted

Deterioration: ☒ broken ☐ cracked ☐ losses ☐ flaking/sugaring ☐ ferrous pins
☐ delamination/detachment ☐ missing fragments ☐ other:

Soiling: ☒ biological ☐ staining ☐ efflorescence ☐ other:

Position: ☐ reset in ground ☒ reset/level to existing base ☐ construct new base
☐ possible new base required ☐ stabilize foundation ☐ resquare

Treatment: ☐ core drill ☒ drill and pin ☐ adhesive repair ☒ infill w/Jahn or U.S. Heritage
☐ injection grout ☐ replace bricks ☐ mortar ☐ repoint ☐ other:

Cost: \$900

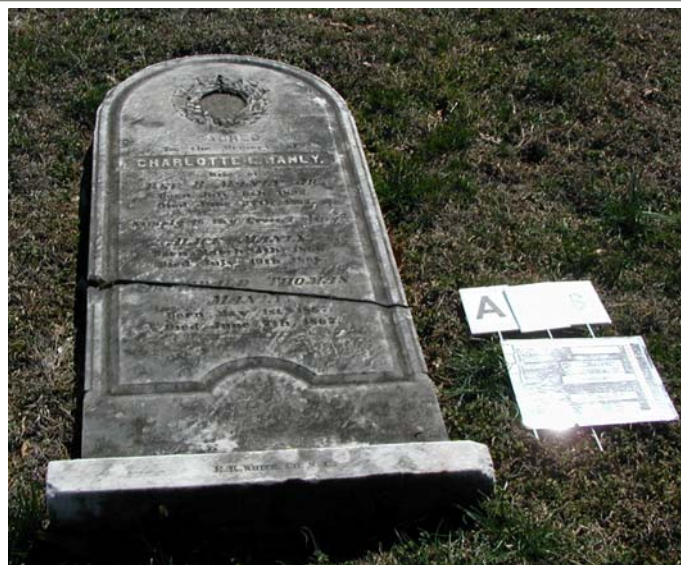
Position: ☐ fallen ☐ unstable ☐ tilted ☒ unattached/loose ☐ missing ☐ shifted

Deterioration: ☐ broken ☒ cracked ☐ losses ☐ flaking/sugaring ☒ ferrous pins
☐ delamination/detachment ☐ missing fragments ☐ other:

Soiling: ☒ biological ☐ staining ☐ efflorescence ☐ other:

Position: ☐ reset in ground ☒ reset/level to existing base ☐ construct new base
☐ possible new base required ☐ stabilize foundation ☐ resquare

Treatment: ☒ core drill ☒ drill and pin ☐ adhesive repair ☒ infill w/Jahn or U.S. Heritage
☐ injection grout ☐ replace bricks ☐ mortar ☐ repoint ☐ other:

Cost: \$950

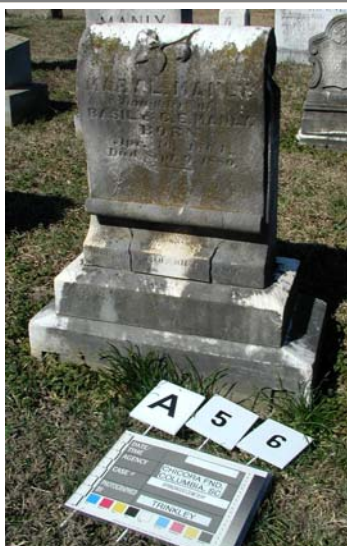
Position: ☐ fallen ☒ unstable ☐ tilted ☒ unattached/loose ☐ missing ☐ shifted

Deterioration: ☐ broken ☒ cracked ☐ losses ☐ flaking/sugaring ☒ ferrous pins
☐ delamination/detachment ☐ missing fragments ☐ other:

Soiling: ☒ biological ☐ staining ☐ efflorescence ☐ other:

Position: ☐ reset in ground ☒ reset/level to existing base ☐ construct new base
☐ possible new base required ☒ stabilize foundation ☐ resquare

Treatment: ☒ core drill ☒ drill and pin ☐ adhesive repair ☒ infill w/Jahn or U.S. Heritage
☐ injection grout ☐ replace bricks ☐ mortar ☐ repoint ☐ other:

Cost: \$950

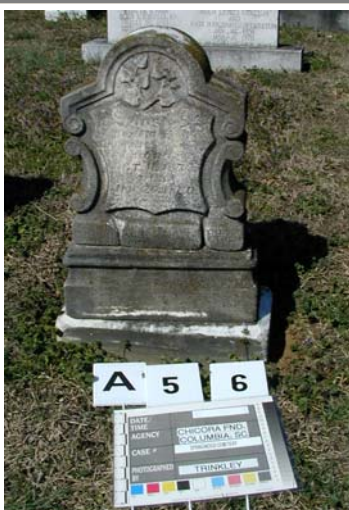
Position: ☐ fallen ☒ unstable ☒ tilted ☒ unattached/loose ☐ missing ☐ shifted

Deterioration: ☒ broken ☐ cracked ☒ losses ☐ flaking/sugaring ☐ ferrous pins
☐ delamination/detachment ☒ missing fragments ☐ other:

Soiling: ☒ biological ☐ staining ☐ efflorescence ☐ other:

Position: ☐ reset in ground ☒ reset/level to existing base ☐ construct new base
☐ possible new base required ☒ stabilize foundation ☐ resquare

Treatment: ☐ core drill ☒ drill and pin ☐ adhesive repair ☐ infill w/Jahn or U.S. Heritage
☐ injection grout ☐ replace bricks ☐ mortar ☐ repoint ☐ other:

Cost: \$500

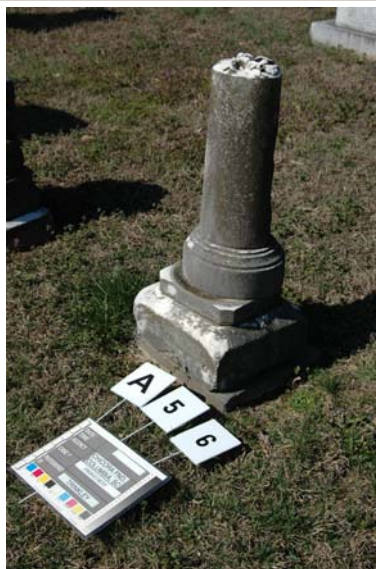
Position: ☐ fallen ☒ unstable ☐ tilted ☒ unattached/loose ☐ missing ☒ shifted

Deterioration: ☐ broken ☐ cracked ☐ losses ☐ flaking/sugaring ☐ ferrous pins
☐ delamination/detachment ☐ missing fragments ☐ other:

Soiling: ☒ biological ☐ staining ☐ efflorescence ☐ other:

Position: ☐ reset in ground ☐ reset/level to existing base ☐ construct new base
☐ possible new base required ☒ stabilize foundation ☒ resquare

Treatment: ☐ core drill ☒ drill and pin ☐ adhesive repair ☐ infill w/Jahn or U.S. Heritage
☐ injection grout ☐ replace bricks ☐ mortar ☐ repoint ☒ other: re-assemble base, add tie rods

Cost: \$1200

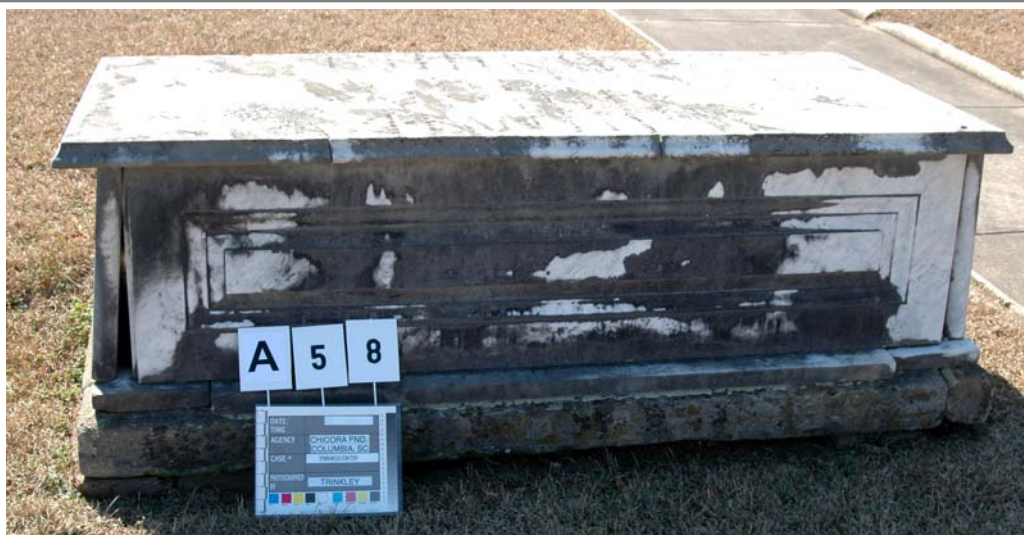
Position: ☒ fallen ☐ unstable ☐ tilted ☒ unattached/loose ☐ missing ☐ shifted

Deterioration: ☐ broken ☐ cracked ☐ losses ☒ flaking/sugaring ☐ ferrous pins
☐ delamination/detachment ☐ missing fragments ☐ other:

Soiling: ☒ biological ☐ staining ☐ efflorescence ☐ other:

Position: ☐ reset in ground ☒ reset/level to existing base ☐ construct new base
☐ possible new base required ☒ stabilize foundation ☐ resquare

Treatment: ☐ core drill ☒ drill and pin ☐ adhesive repair ☐ infill w/Jahn or U.S. Heritage
☐ injection grout ☐ replace bricks ☐ mortar ☐ repoint ☐ other:

Cost: \$450

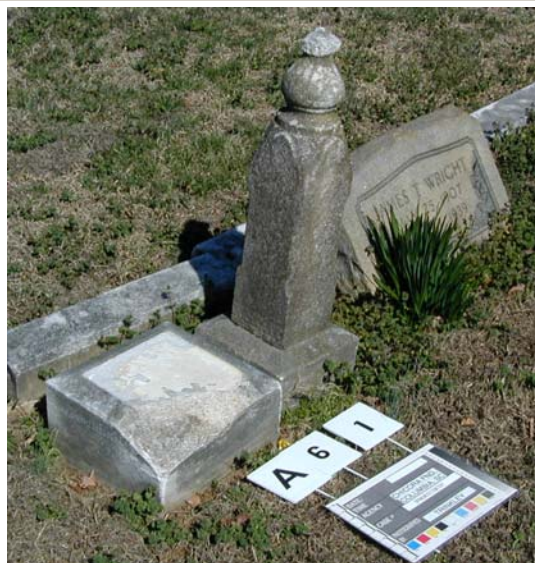
Position: ☐ fallen ☐ unstable ☐ tilted ☒ unattached/loose ☐ missing ☐ shifted

Deterioration: ☒ broken ☐ cracked ☐ losses ☐ flaking/sugaring ☐ ferrous pins
☐ delamination/detachment ☐ missing fragments ☐ other:

Soiling: ☒ biological ☐ staining ☐ efflorescence ☐ other:

Position: ☐ reset in ground ☒ reset/level to existing base ☐ construct new base
☐ possible new base required ☐ stabilize foundation ☐ resquare

Treatment: ☐ core drill ☒ drill and pin ☐ adhesive repair ☒ infill w/Jahn or U.S. Heritage
☐ injection grout ☐ replace bricks ☐ mortar ☐ repoint ☐ other:

Cost: \$200

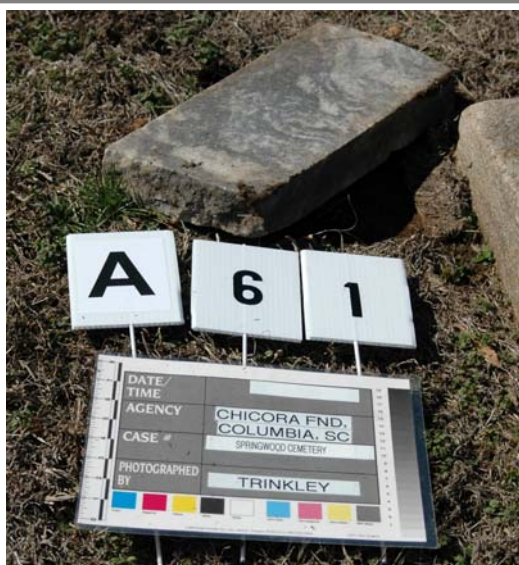
Position: ☐ fallen ☐ unstable ☐ tilted ☒ unattached/loose ☐ missing ☐ shifted

Deterioration: ☒ broken ☐ cracked ☐ losses ☐ flaking/sugaring ☐ ferrous pins
☐ delamination/detachment ☐ missing fragments ☐ other:

Soiling: ☒ biological ☐ staining ☐ efflorescence ☐ other:

Position: ☐ reset in ground ☐ reset/level to existing base ☐ construct new base
☐ possible new base required ☐ stabilize foundation ☐ resquare

Treatment: ☐ core drill ☒ drill and pin ☐ adhesive repair ☒ infill w/Jahn or U.S. Heritage
☐ injection grout ☐ replace bricks ☐ mortar ☐ repoint ☒ other: re-assemble base

Cost: \$1400

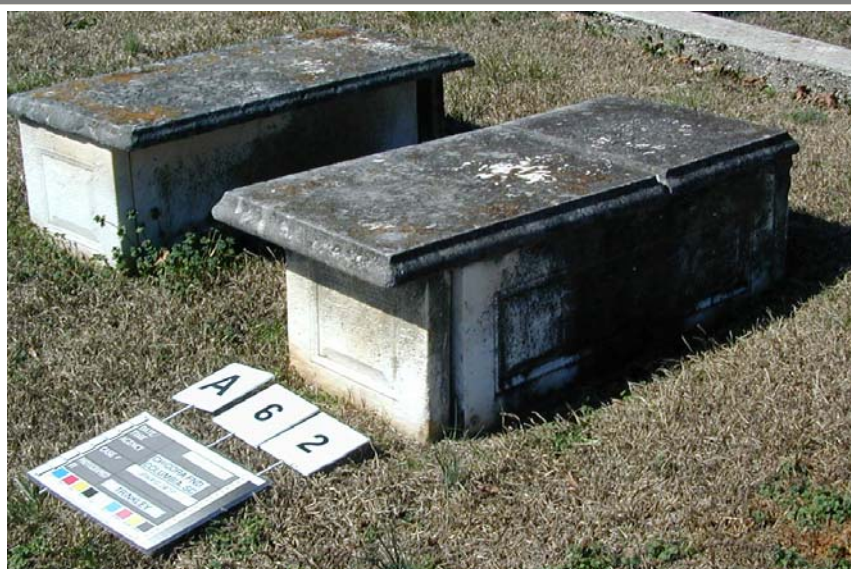
Position: ☐ fallen ☐ unstable ☒ tilted ☒ unattached/loose ☐ missing ☐ shifted

Deterioration: ☐ broken ☐ cracked ☐ losses ☐ flaking/sugaring ☐ ferrous pins
☐ delamination/detachment ☐ missing fragments ☐ other:

Soiling: ☐ biological ☐ staining ☐ efflorescence ☐ other:

Position: ☒ reset in ground ☐ reset/level to existing base ☐ construct new base
☐ possible new base required ☒ stabilize foundation ☐ resquare

Treatment: ☐ core drill ☐ drill and pin ☐ adhesive repair ☐ infill w/Jahn or U.S. Heritage
☐ injection grout ☒ replace bricks ☐ mortar ☒ repoint ☐ other:

Cost: \$400
